ARMY ENGINEER WATERWAYS EXPERIMENT STATION VICKSBURG--ETC F/G 8/6  
ENGINEERING GEOLOGY AND GEOMORPHOLOGY OF STREAMBANK EROSION. RE--ETC(U)  
OCT 81 C B WHITTEN, D M PATRICK

4. TITLE (and Subtitle) ENGINEERING GEOLOGY AND GEOMORPHOLOGY OF STREAM- BANK EROSION; Report 2, YAZOO RIVER BASIN UPLANDS, MISSISSIPPI	5. TYPE OF REPORT & PERIOD COVERED Report 2 of a series

7. AUTHOR(s) Charlie B. Whitten David M. Patrick	6. PERFORMING ORG. REPORT NUMBER Jun 77 - Aug 78	
9. PERFORMING ORGANIZATION NAME AND ADDRESS U. S. Army Engineer Waterways Experiment Station Geotechnical Laboratory P. O. Box 631, Vicksburg, Miss. 39180	8. CONTRACT OR GRANT NUMBER(s)

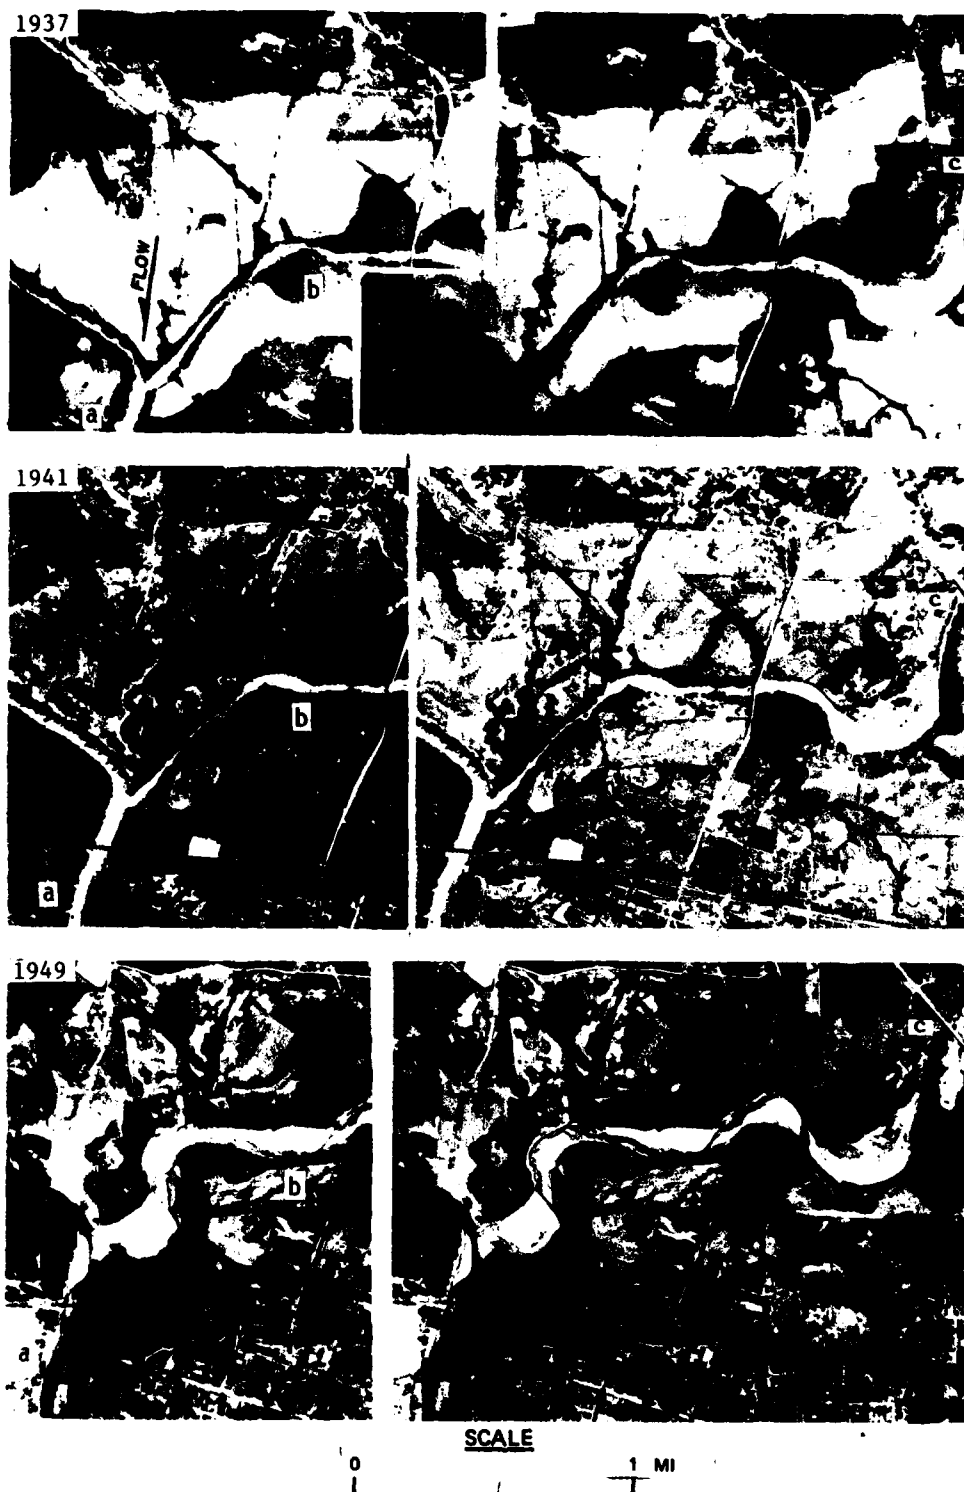
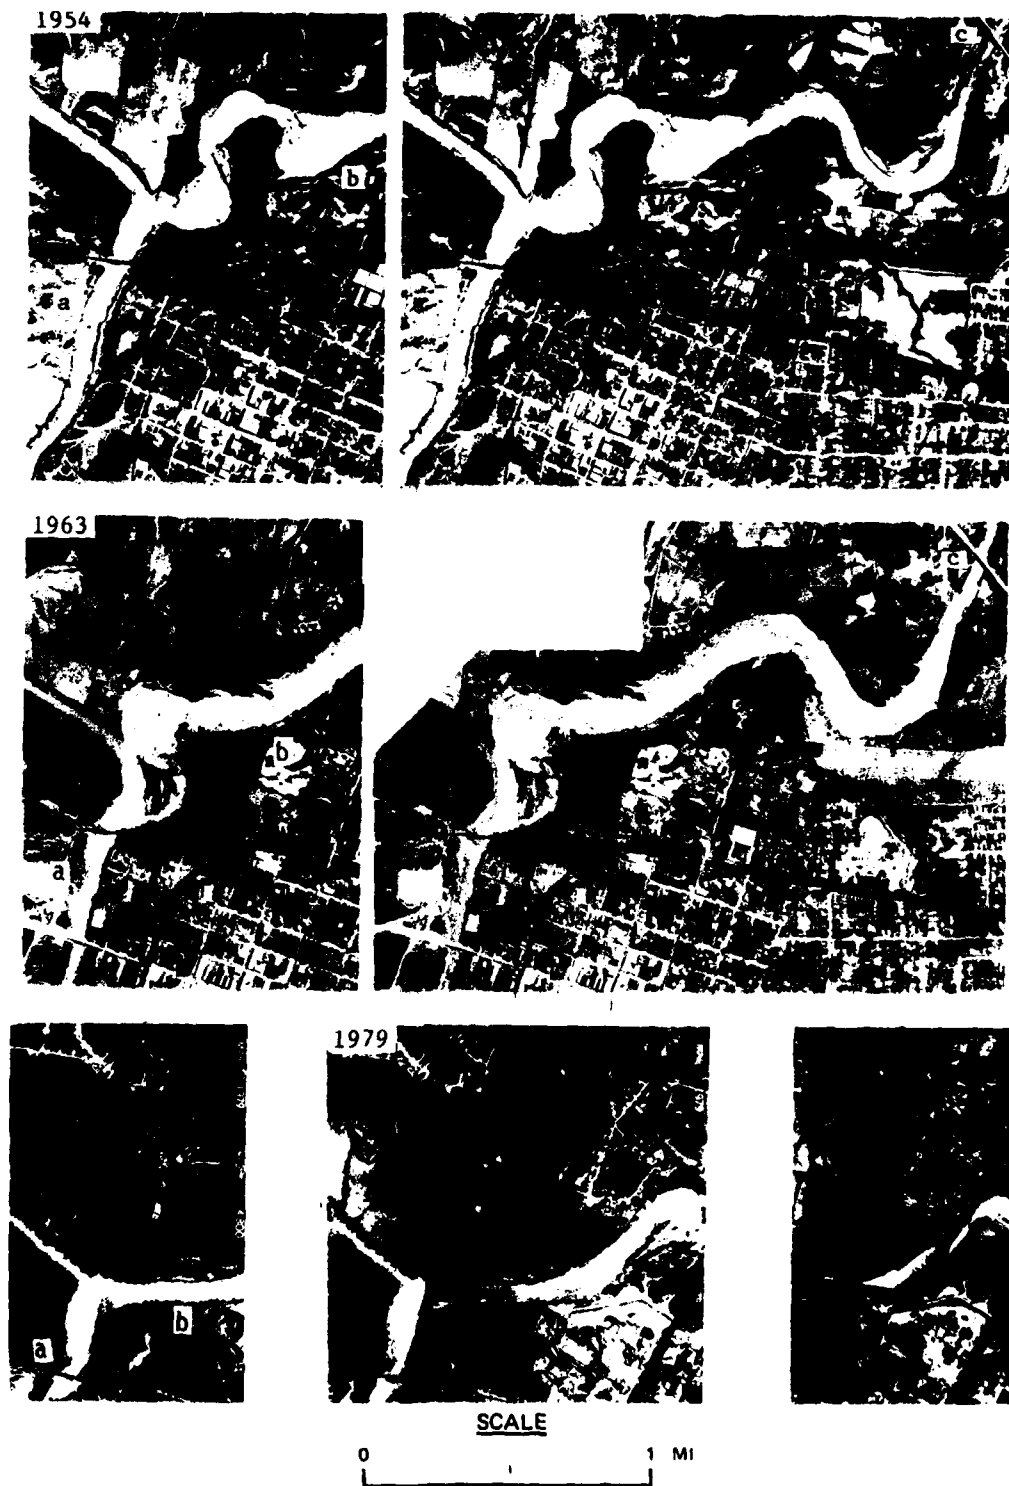
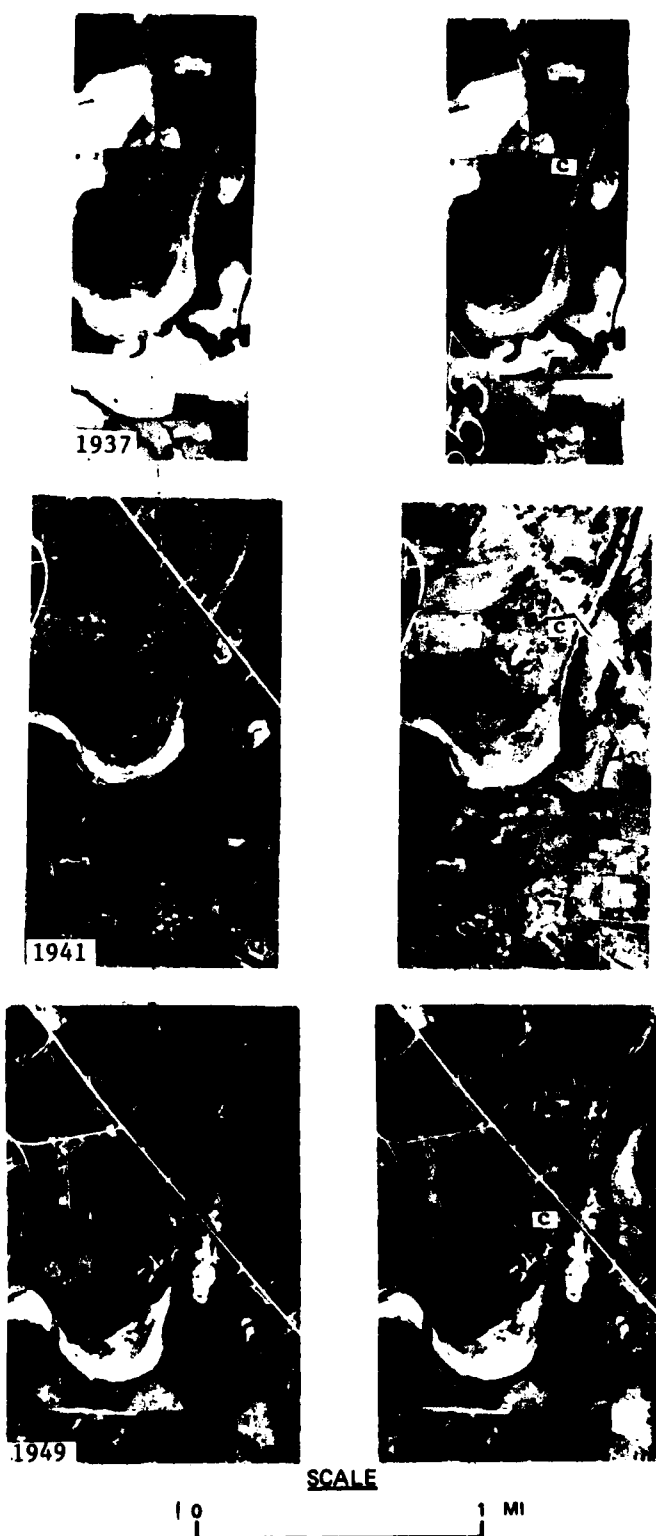
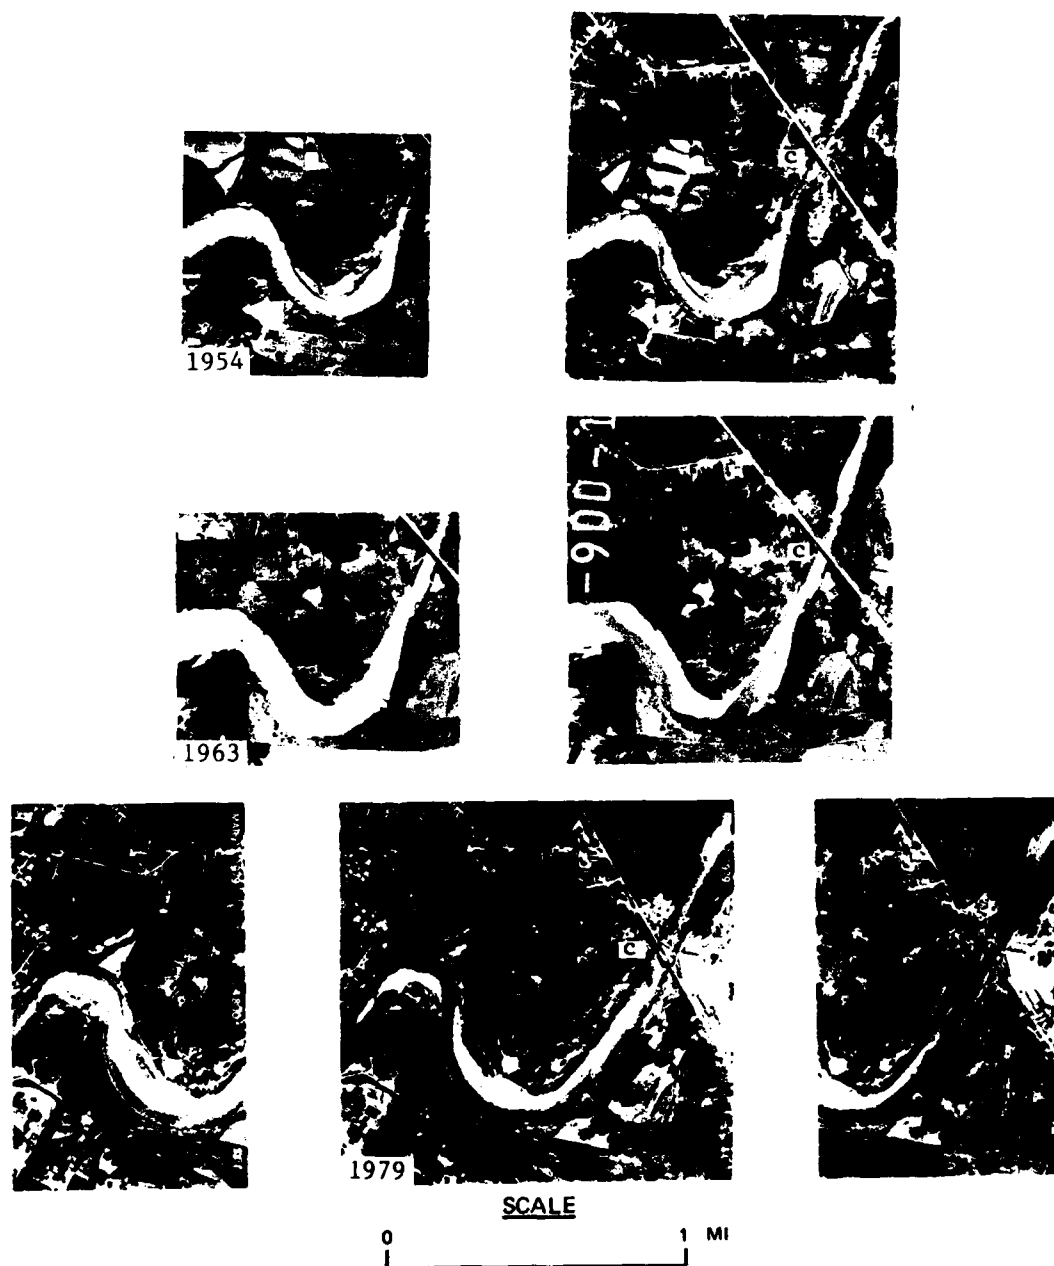
Figure 90. Mouth of Batupan Bogue (Symbol "a" designates Yalobusha River, "b" is Batupan Bogue.) (Sheet 1 of 4)

point, probably Tallahatta shale (Figure 89). A chronological sequence of aerial photographs shows the channel erosion, especially bank erosion, that has occurred at the mouth of Batupan Bogue since 1937 (Figure 90). The tributaries of Batupan Bogue, such as Perry Creek, are responding to the degradation of Batupan Bogue by also degrading (Figure 91).

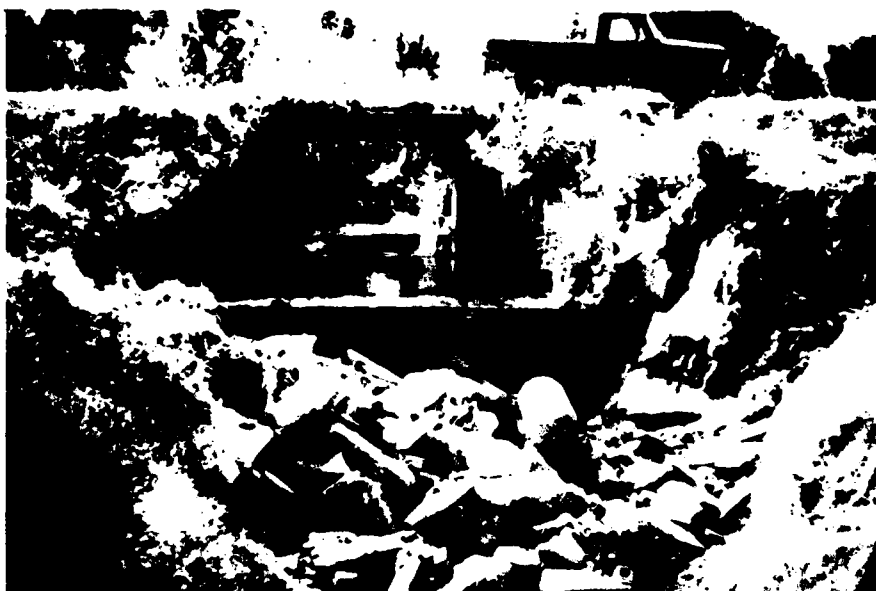
a. Mouse Creek

b. Mouse Creek directly downstream of "a"

Figure 91. Channel erosion on Batupan Bogue tributaries in 1977 (Continued)

c. Worsham Creek

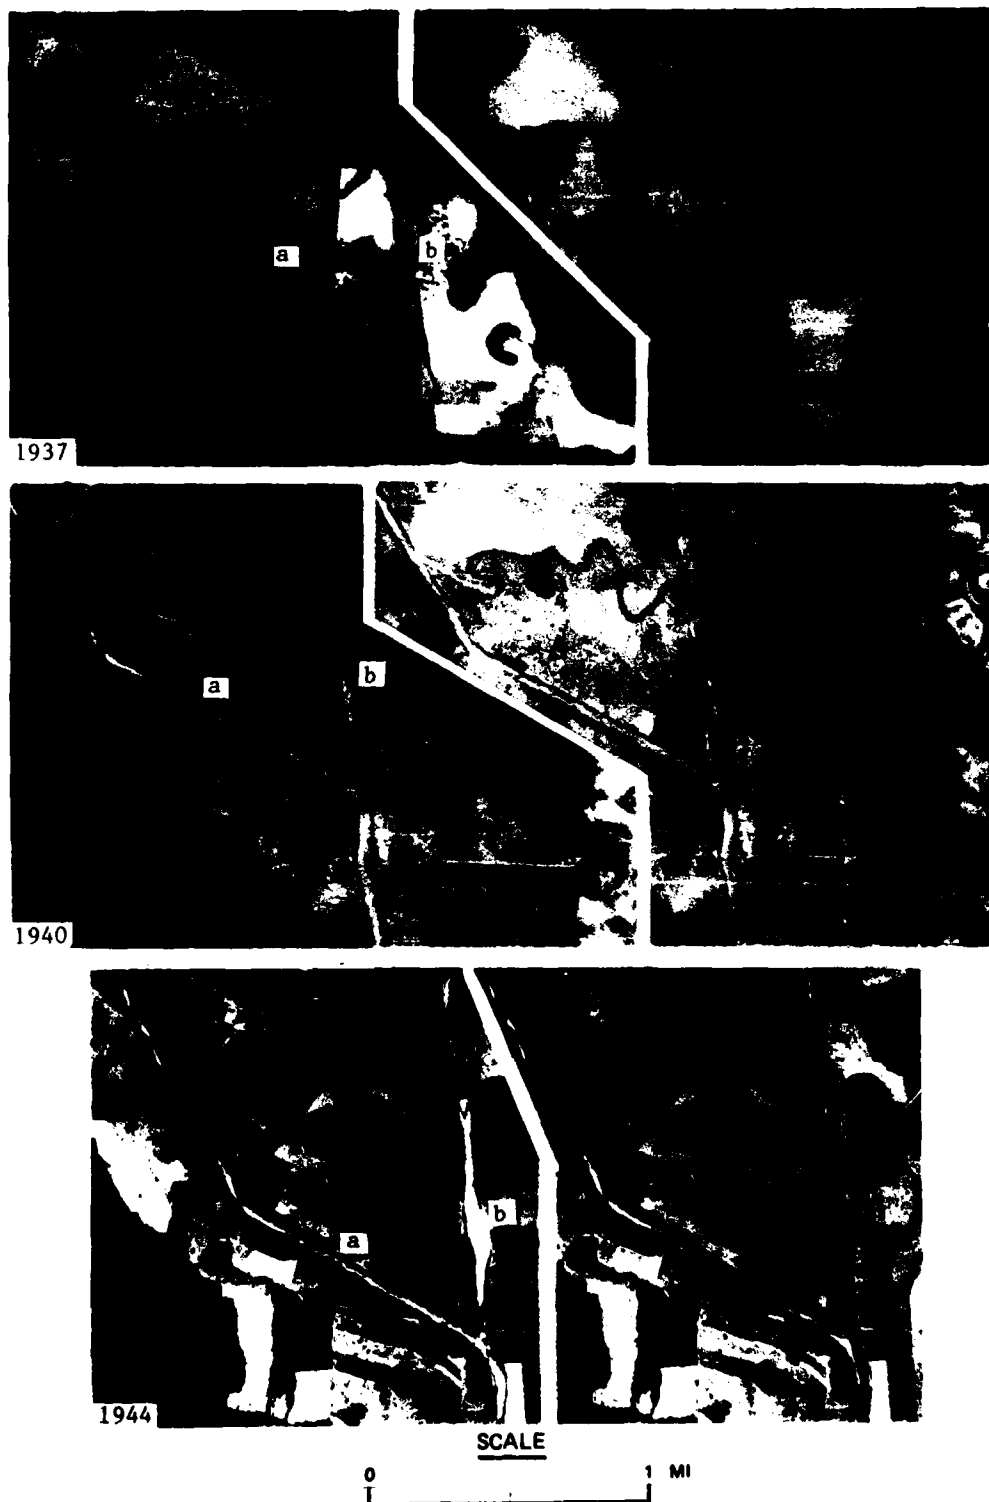
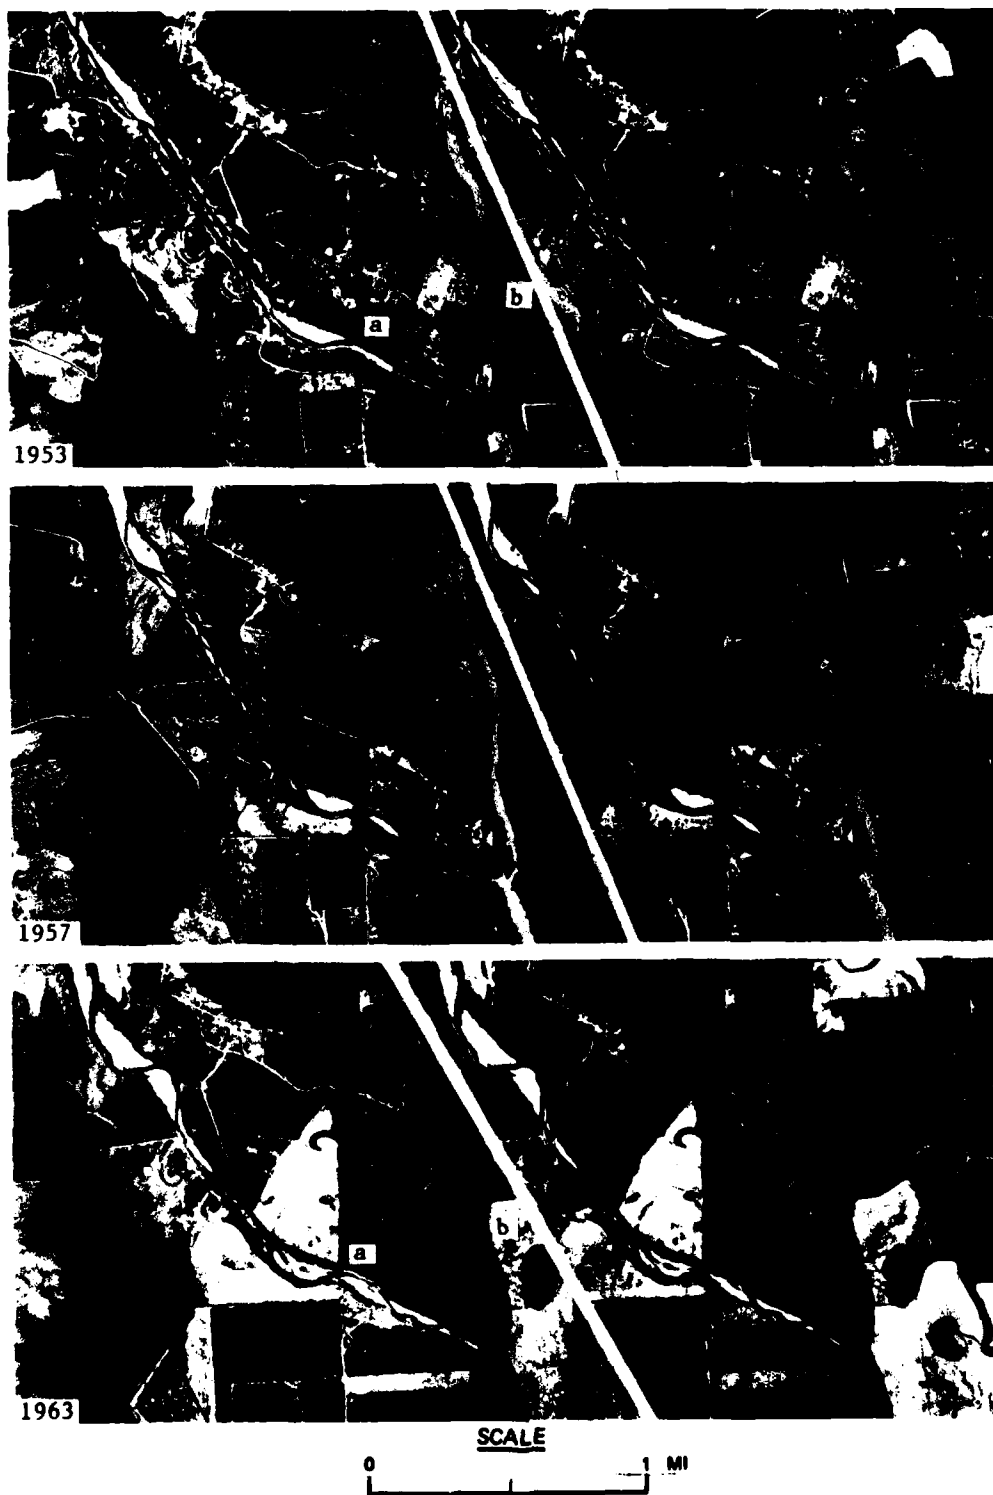
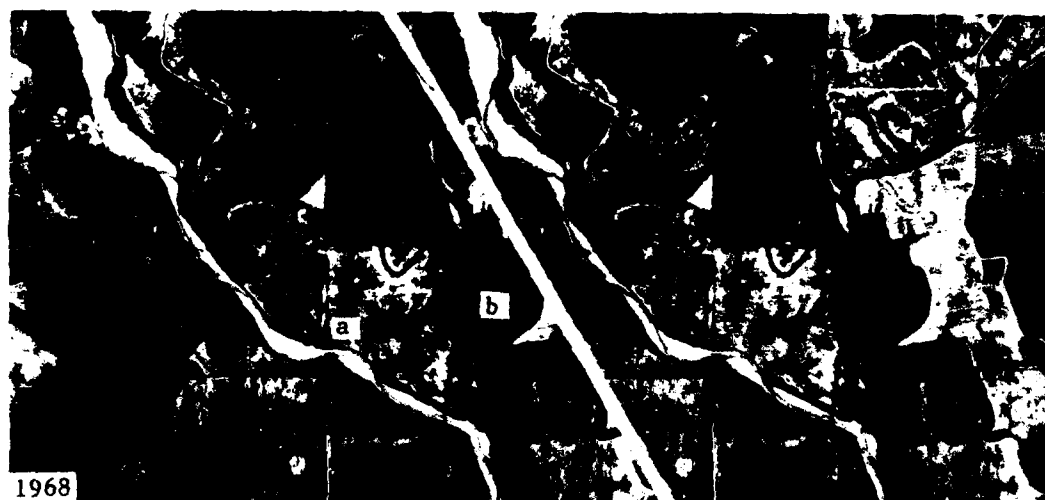
Figure 93. Mouth of Peters Creek (Symbol "a" designates Peters Creek, and "b" is the Yocona River.) (Sheet 1 of 3)

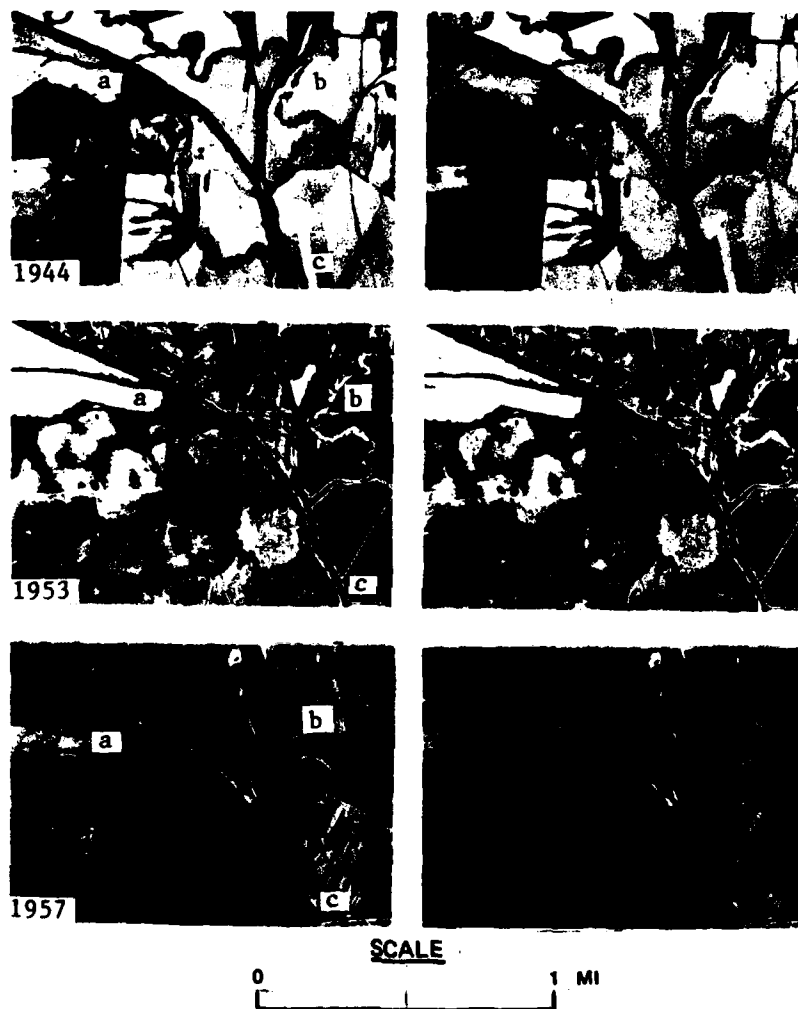
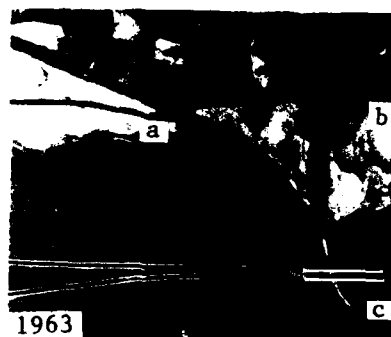
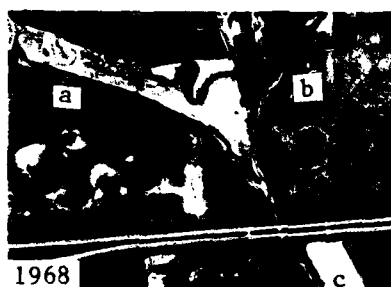
153. Peters Creek is formed by the junction of Long and Johnson Creeks. Peters Creek and the lower reaches of Long and Johnson Creeks were channelized prior to 1935. A chronological sequence of aerial photographs at the head of Peters Creek shows no major observable channel erosion until 1963 (Figure 94). Note the narrow, meandering prechannelization channels in Figure 94. Channel erosion had doubled the channel width by 1979 and increased the channel depth.

154. The Yocona River degraded approximately 5 ft at the mouth of Peters Creek from 1953-61, and the first observable significant channel erosion at the head of Peters Creek occurred between 1957 and 1963. Since the base level of a tributary is controlled by its trunk stream,

Figure 94. Junction of Long and Johnson Creeks to form Peters Creek (Symbol "a" designates Johnson Creek, "b" is Long Creek, and "c" is Peters Creek.) (Continued)

it seems logical to assume the degradation at the head of Peters Creek was caused by degradation of the Yocona River and that the degradation has advanced up Long Creek to Goodwin Creek.
